Document Title	NON-OPERATIONAL RANDOM VIBRATION AND TRAPEZOIDAL SHOCK TEST RESULT	Document Number	Revision	Page	
		SLVS-0004	A	1	3

NVIDIA BOARD + CARDKEEPER (BUBBA WITH TAB) STIFFENER

600-10172-0001-000 WITH CARDKEEPER CK03-1255

SETUP ON PRESARIO 8000 TEST PLATFORM

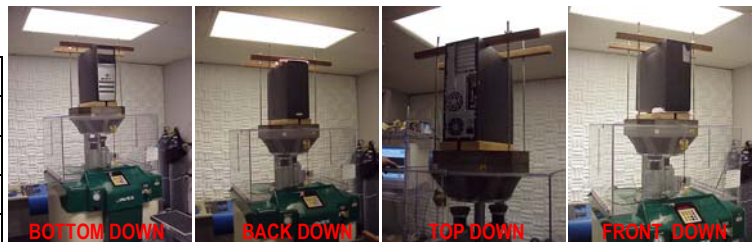
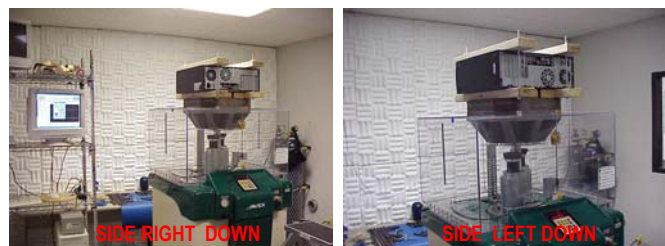
Picture shown is a P172 board with the stiffener installed on a Presario 8000 test platform and setup of the 6 axis.

TEST PERFORMED	TEST CONDITIONS	TEST ORIENTATION	RESULTS		Mfg Diags Pre/Post	BIOS Pre/Post
			SAMPLE #1	SAMPLE #2		
Non-Operating - Trapezoidal Shock	35 G, 150 in/sec on a Presario 8000 test platform. One shock input on each direction or a total of six shock inputs.	BOTTOM DOWN	PASSED	PASSED	618-20606-3700-CX8	04.35.20.23.04
		BACK DOWN	PASSED	PASSED		
		SIDE-LEFT DOWN	PASSED	PASSED		
		TOP DOWN	PASSED	PASSED		
		FRONT DOWN	PASSED	PASSED		
		SIDE-RIGHT DOWN	PASSED	PASSED
